LOTES DAM
WAYNE COUNTY, MISSOURI
MISSOURI INVENTORY NO. 30309

PHASE I INSPECTION REPORT
NATIONAL DAM SAFETY PROGRAM

AUGUST 1979

Name of Dam	Lottes Dam
State Located	Missouri
County Located	Wayne County
Stream	Unnamed tributary to West Fork Creek
Date of Inspection	17 May 1979

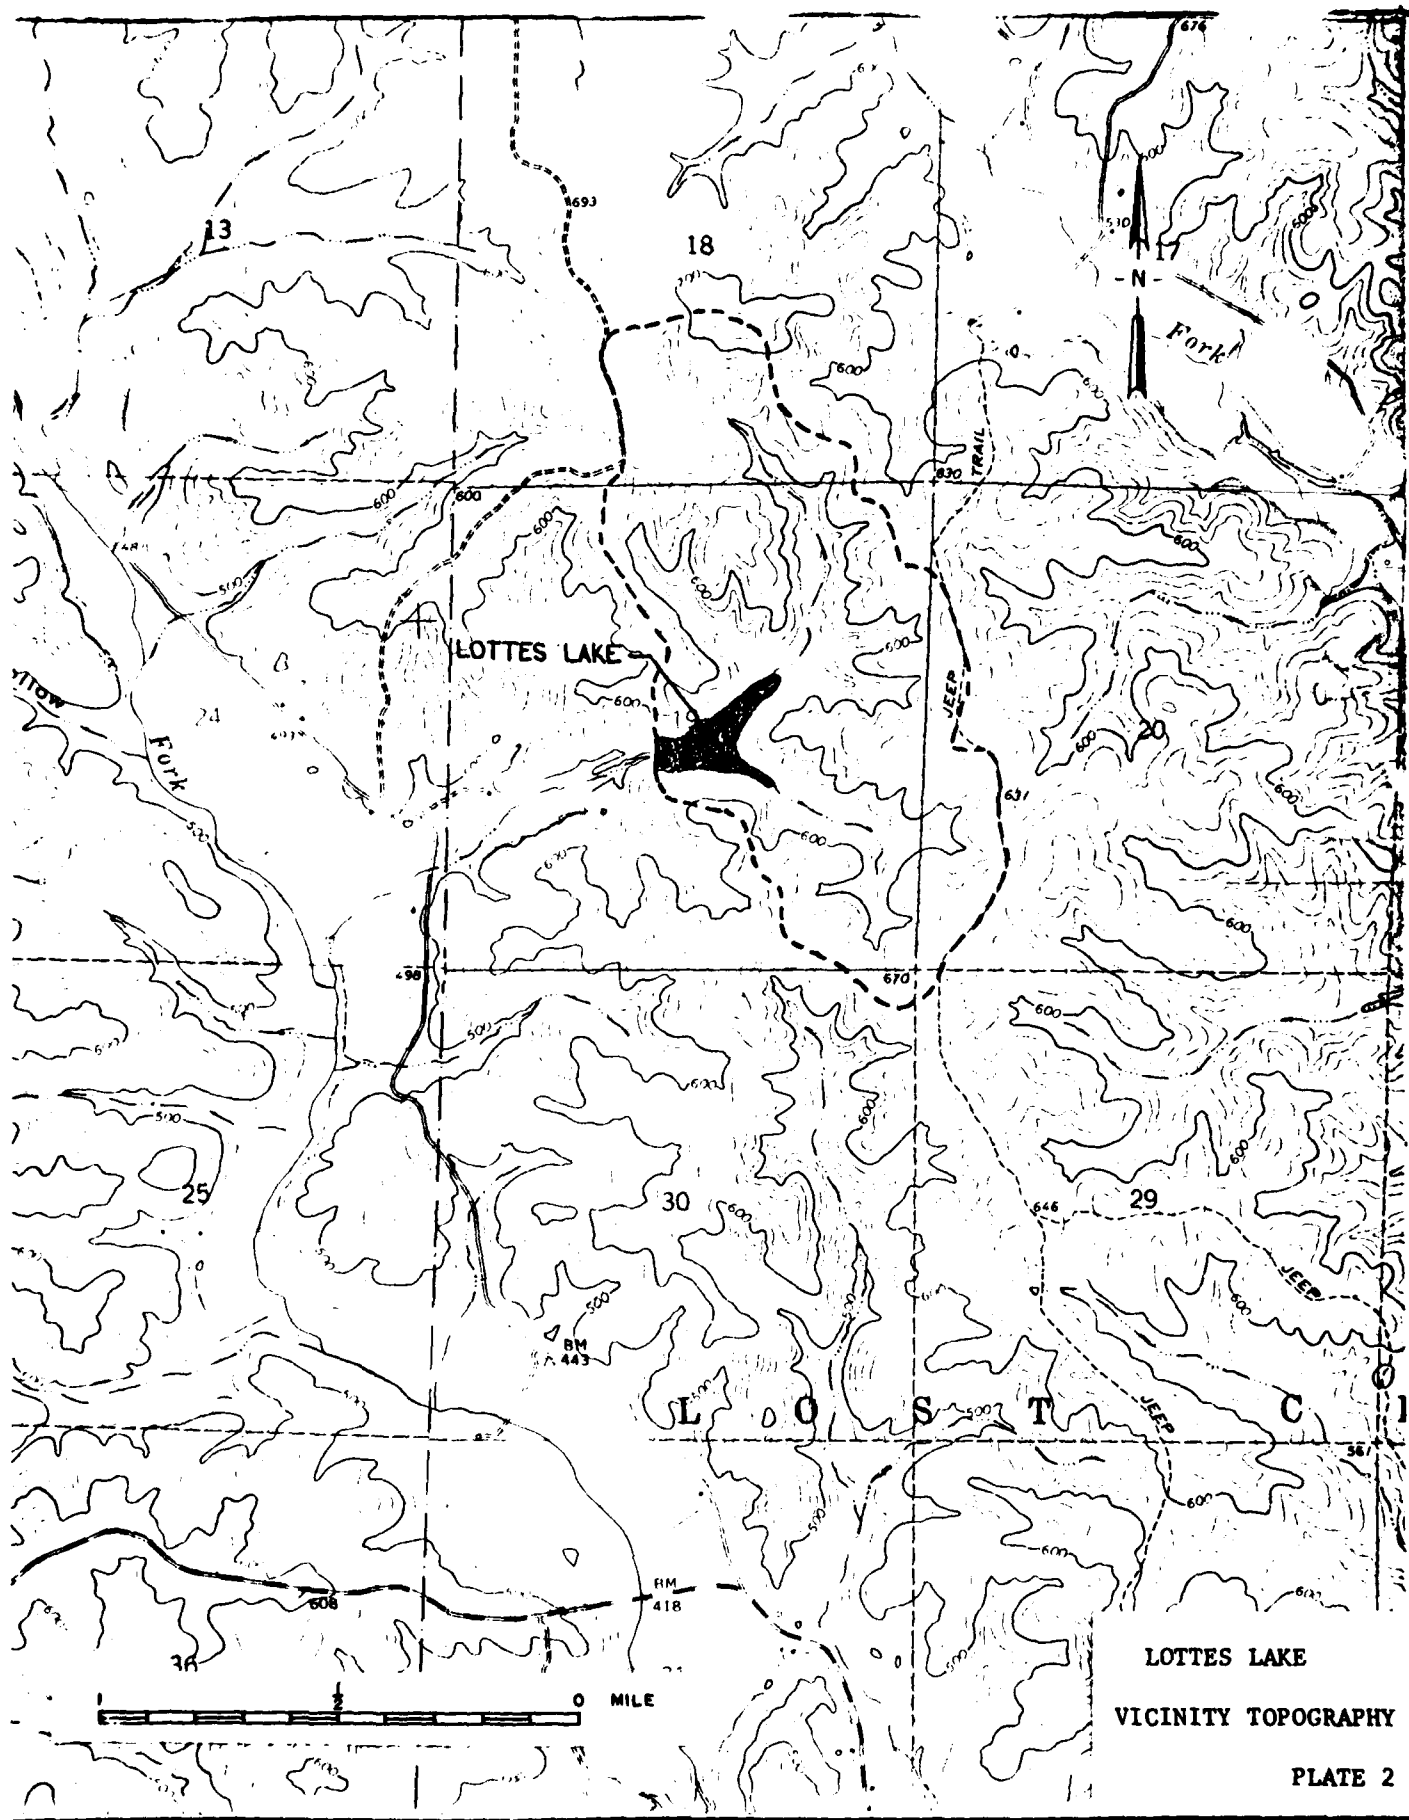
LOTES LAKE
VICINITY TOPOGRAPHY
PLATE 2

(1) The dam is an earth structure built in a narrow valley in the uplands which border the Mississippi Embayment. Topography adjacent to the valley is rolling to steep. Soils in the area are formed of red silty clays with fragments of dolomite and chert. Topography in the vicinity of the dam is shown on Plate 2.
